Fault Location and Diagnosis in a Medium Voltage EPR Power Cable

This paper presents a case study on fault location, characterisation and diagnosis in a length of shielded 11 kV medium voltage ethylene-propylene rubber (EPR) power cable. The defect was identified on-site as a low resistance fault occurring between the sheath and the core. A 43 m section was removed for further analysis. The fault resistance was characterised and the location of the defect pinpointed to within a few cm using a combination of time-difference-of-arrival location and infra-red imaging. A combination of X-ray computed tomography, scanning electron microscopy and energy dispersive X-ray spectroscopy were then applied to characterise any abnormalities in the dielectric surrounding the breakdown region. A significant number of high density contaminants were found to be embedded in the dielectric layer, having an average diameter of the order of 100 μm , a maximum diameter of 310 μm and an average density of 1 particle per 2.28 mm^3 . Scanning electron microscopy and energy-dispersive X-ray spectroscopy were used to determine the geometry and elemental composition of some initial contaminant samples. It wa

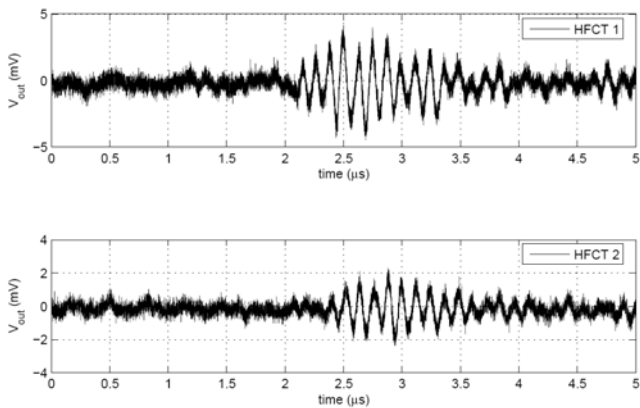
Figure 3. Measured traces at the respective HFCTs arising from breakdown at the site of the cable fault. $\Delta t = 261$ ns.

where Δt is the time-difference-of-arrival between measured signals at HFCTs 1 and 2. This was achieved by identifying similar features on the respective waveforms arriving at each HFCT, such as the initial peaks, and estimating the time difference between these features. Taking into account measurement errors in Δt and ΔT , the signals shown in Figure 3 correspond to a fault location of $d = 2.18 \pm 0.56$ m from HFCT1 (see Figure 1).

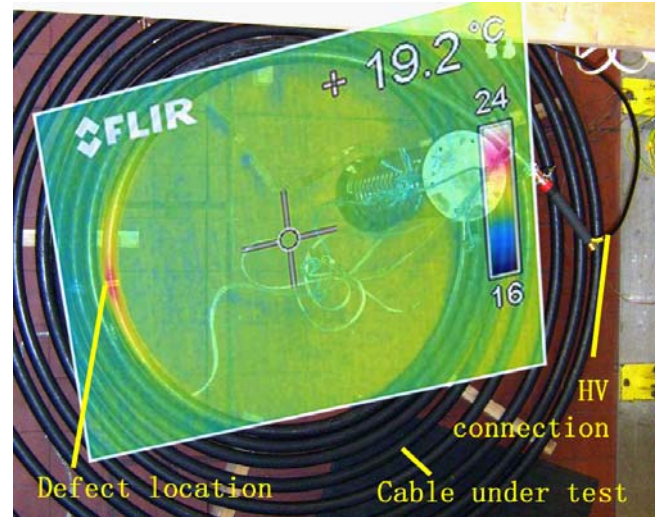
Figure 4. Fault location using infra red imaging. The location is 1.8 m from the cable datum end. For clarity, this composite image consists of the thermal image superimposed on a photograph of the experimental setup.

The cable had been placed in a spiral arrangement so that the entire cable length was within the field of view. The site of the fault was apparent on the inner coil of the spiral arrangement as evidenced by increased temperature in the region. Once thermal equilibrium was reached the peak cable temperature was found to be 21.7°C (2.5°C above the ambient level).

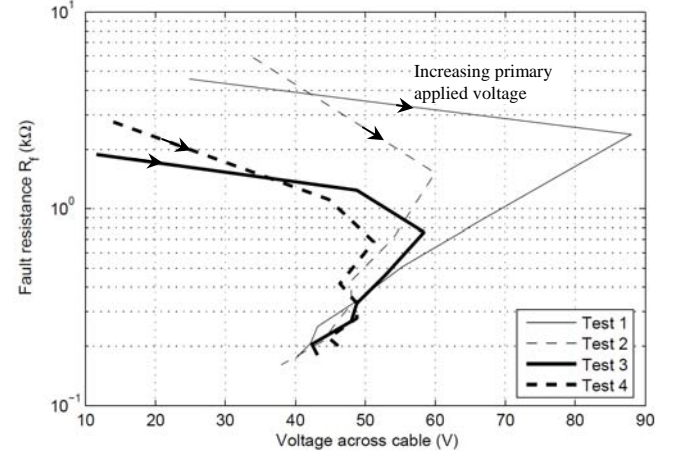
Figure 7. Variation of fault resistance with the voltage across the cable.

Arrows shown in the figure indicate an increasing supply voltage (and current) applied at the primary winding. In each of the four tests, a corresponding increase occurs in the voltage across the cable, until the fault reaches a transition point where its resistance decreases significantly. In each of the test cases, the defect resistance approaches a minimum of around 200 Ω at the maximum applied primary voltage. This minimum value was consistent with that initially obtained by the site engineer, leading to decommissioning of the cable.

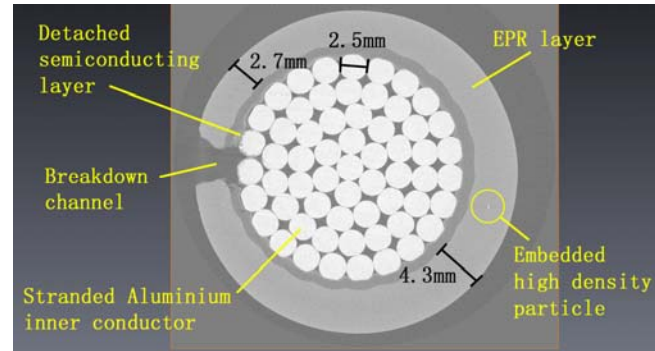
Figure 8. Reconstructed X-ray slice through defective cable section showing breakdown channel and conducting particle contaminant.

Several features are immediately evident. Firstly, the breakdown channel is clearly visible, having a diameter of 2-3 mm. Tracking caused by the breakdown current has extensively degraded the dielectric so that the channel is essentially an air gap at this stage. Secondly, the breakdown has caused the inner semiconductor to detach from the inner conductor leaving a cavity. Thirdly, eccentricity is evident, with a 1 mm offset between the longitudinal central axes of the aluminium stranded core and the EPR insulation layer, resulting in an increased insulation gap on one side of the cable and a reduced insulation gap on the other. Fourthly, the presence of at least one high-density particle with an approximate diameter of 100 μm is evidently embedded within the insulation layer. The particle appears to have a similar density to that of the aluminium core. The appearance of the particle on this arbitrary cross section suggests a possible high contaminant density in this region.

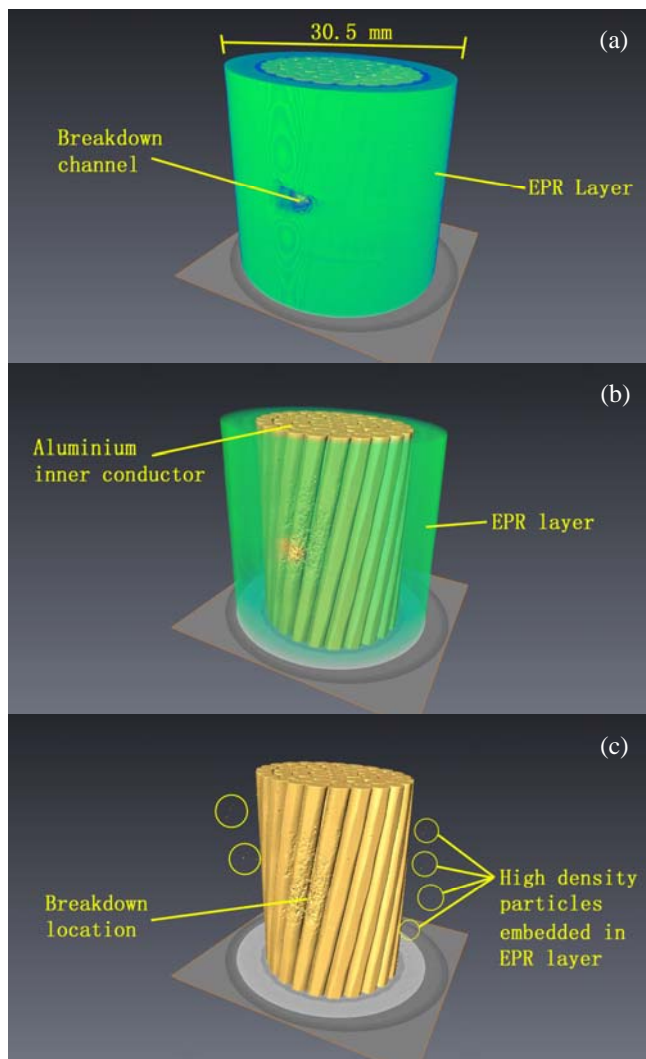
Fig. 9 shows the results of volume rendering of the reconstructed data. Rendering the high-density region as an isosurface, while separately rendering the volume of the EPR and semiconducting layers, allowed the effect of artificially removing the insulation layer. This revealed the presence of multiple high-density contaminants. Several contaminants have been highlighted in Fig. 9 (c) for illustration purposes. Damage to the inner core is evident around the breakdown region as is an increased contaminant density. Due to sustained stressing, the fault has largely disintegrated the EPR region surrounding it. Particle diameters are of the order of 100 μm.

Figure 9. Reconstructed cable geometry from X-ray scans. (a) EPR layer is fully visible, (b) EPR layer set to semi-transparent, (c) EPR layer hidden to show particle contamination and damage to inner conductor.

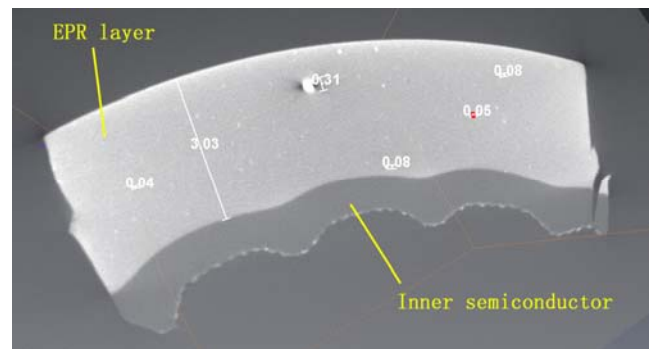
Figure 10. Reconstructed 2D orthographic slice of a thin sample of insulator near the defect region. Embedded high density particles appear as light regions. Dimensions are in mm.

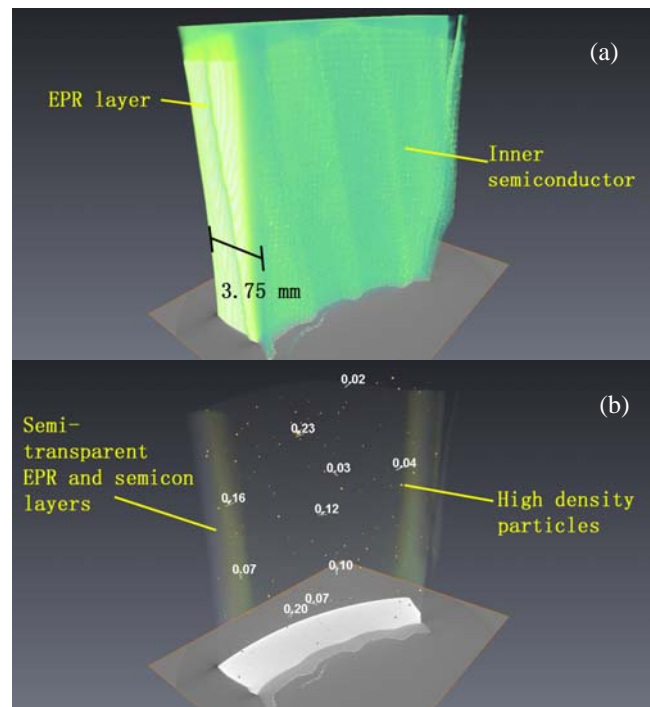
Fig. 11 shows the reconstructed volume of the small dielectric sample. Setting the low-density insulation region as a semitransparent layer reveals the embedded contaminants. The average particle density in this region is 1 particle per 2.28 mm^3 .

Figure 11. Reconstructed 3D geometry of a thin sample of insulator and semiconductor removed from near the defect region. (a) Semiconducting and EPR layers fully visible, (b) EPR and semiconducting layers set semitransparent to reveal embedded high density particles. Dimensions in mm.

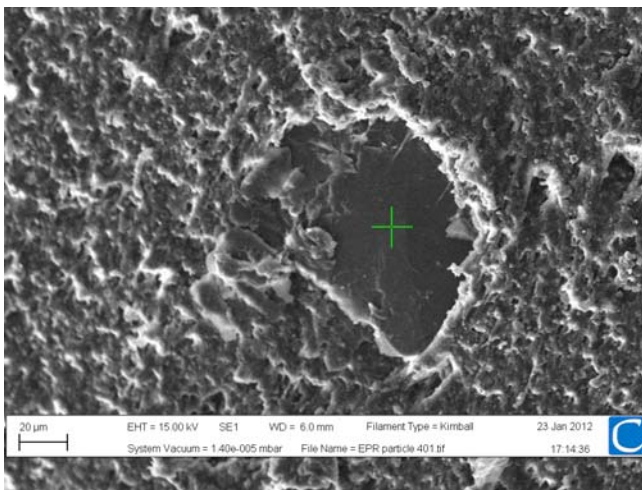
Figure 12. SEM micrograph of a sliced surface of EPR insulating material from the cable sample showing an embedded high density particle.
