Seventeenth and eighteenth century timber roof structures in Scotland: design, pathologies and conservation

A. Serafini & C. Gonzalez Longo

Department of Architecture, University of Strathclyde, Glasgow, UK

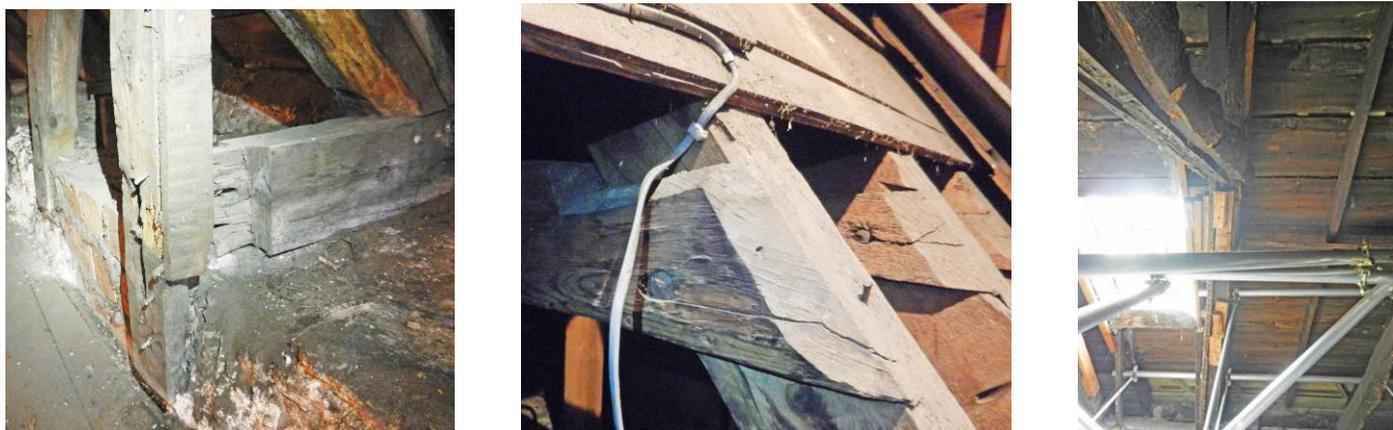
Common rafter roofs show joint disconnections/splitting that can be associated with an overall transversal opening of the roof. As already stated, up to about 1670 simple lap or mortise and tenon joints are used, secured with timber pegs. These joints are

not capable of resisting tension forces, which the lower collars and rafter feet are subject to. The timber pegs fail easily (also because of biotic attack) and the joints start opening (Fig. 5 left). Even in later roofs, dovetail joints can fail if the timber cracks and splits around the metal nail (Fig. 5 center).

Other common rafter roofs have a problem in the longitudinal direction, with the frames stacking up and losing stability (Fig. 5 right). This seems to happen when the distance between the frames is more than the common 50cm, because the longitudinal rigidity is provided only by the sarking boards.

Figure 5. Mechanical damage in common rafter roofs. From left to right: joint disconnection in Sailor's Walk (Kirkcaldy, Fife), joint splitting in Touch House (St Ninians, Stirling), stacking up in Geilston House (Cardross, Argyll and Bute).

Common rafter roofs also have material degradation problems (fungi, insects, etc), that might be caused, amongst other, by the rough dressing of the timber elements, which often retain some bark and sapwood, more subject to biotic attack (Ridout 1999). Trusses and purlin roofs seem to be less vulnerable, probably because the timber for these bigger and more complex structures was carefully selected to be of high quality, and carefully squared and finished.

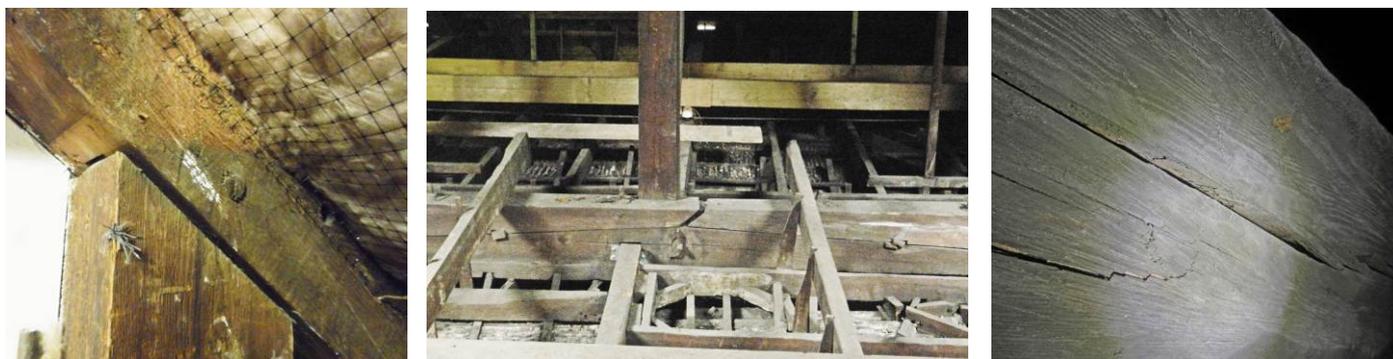
Trusses with spans below 10m are generally in good conditions, whilst those covering bigger spans sometimes have deflections in rafters and tie-beams, joint disconnections and cracks (Fig. 6), which suggest an

Figure 6. Mechanical damage in Trussed roofs. From left to right: joint disconnection in Fort George Ordnance Store (Ardersier, Highland), joint disconnection in Oakshaw Trinity Church (Paisley, Renfrewshire), crack in rafter in Glasgow Trades Hall.

overall deflection and opening of the roof structure. One of the causes is the improper design of arrangements and joints: timber elements are often too long and do not have sufficient propping provided; joints are almost exclusively mortise and tenon secured by timber dowels or nothing, which work only in compression (Fig. 6, left); metals straps are very seldom used and sometimes they are a later addition; scarf joints, when used, are very simple (Fig. 6 center), and again unable to absorb tension forces.

Gardyne's Land (end seventeenth century), for example, has deflected collars in the central part of the roof, where a pediment was added in early 18C (Fig. 8 left). Another example is Oakshaw Trinity church, where the heavy plaster ceiling was probably added/replaced in nineteenth century, causing deflections and joint disconnections due to the additional dead load (Fig. 6 center).

vention actually increased the loads on the tie-beams, increasing their deflection and joints' opening (Fig. 6 center), and on the masonry, causing cracks. Checks and cracks, with no distinction, are often filled with resin. Checks are natural cracks that develop along the radius of a log, when the timber dries. They rarely are a structural problem. Filling them actually weakens the timber preventing it from 'breathing', and can cause further cracks to develop.

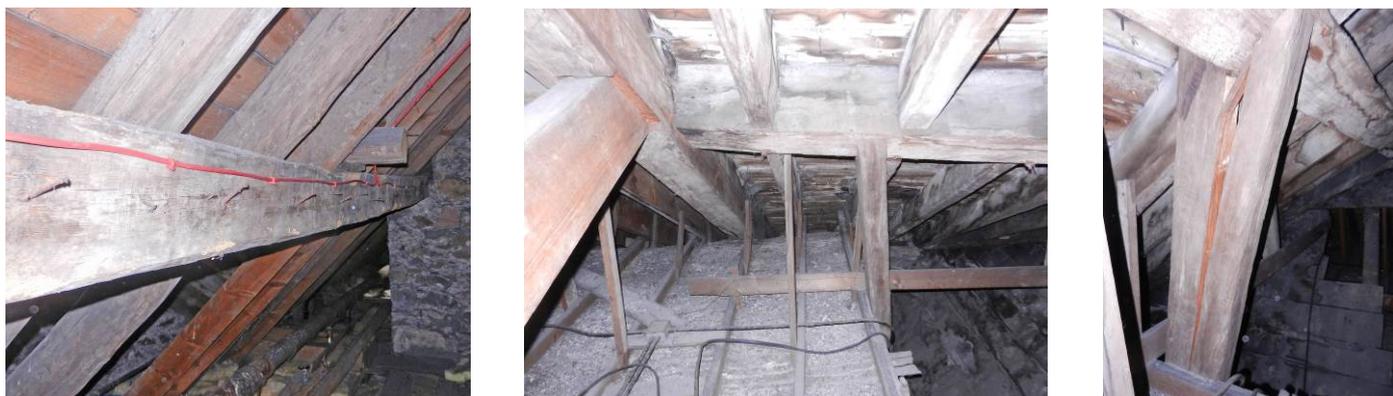
Figure 7. Mechanical damage in purlin roofs. From left to right: deflected purlin in Melville House (Monimail, Fife), deflected purlin in Touch House (St Ninians, Stirling), crack in strut in Touch House (St Ninians, Stirling).

Purlin roofs often have deflected purlins and cracked struts (Fig. 7), caused by insufficient dimensions or lack of supports.

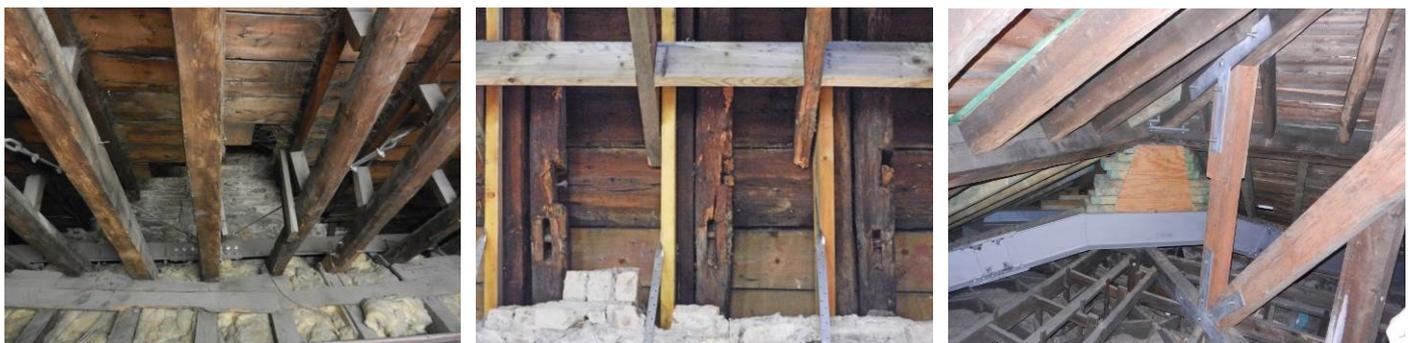
There is often no documentation on past repairs and why they have been done. Temporary interventions often become permanent, and their effect on the structure is not monitored. Whilst in eighteenth and nineteenth century timber was used to either replace the whole roof or double its structure (Fig. 8 center), in the twentieth and twenty-first century steel became more fashionable. The weight of steel is often a problem for the masonry and the plaster ceilings. For example, timber posts and steel beams were added in Oakshaw Trinity church to support the hip rafters that were deflecting (Fig. 8 right); this inter-

Figure 8. Past interventions. From left to right: Steel beam and ties counteracting the collars' deflection in Gardyne's Land (Dundee), 18C and 21C timbers strengthening the original 17C timbers in Panmure House (Edinburgh), timber posts/struts and steel beams/straps counteracting the hip rafters' deflection in Oakshaw Trinity church (Paisley).
