Designing for Reliability in Wind Turbine Condition Monitoring Systems

2.0 Vestas V47 Condition Monitoring System

3.0 New and Improved CMS for a Vestas V42 Wind Turbine

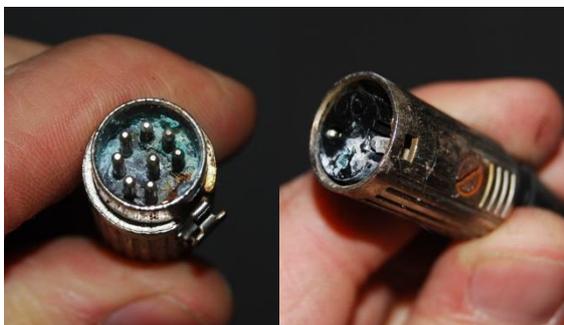
On decommissioning the CMS several factors were found that could have caused signal degradation. One of these factors was the build-up of corrosion on the pins within one of the connectors. It is notable that the sensor with this corrosion was located at the hub of the wind turbine where the main shaft enters the nacelle. This increased corrosion may be the result of increased moisture levels at the hub where precipitation can more easily penetrate the nacelle.

Figure 1: Connector corrosion

As can be seen from Figure 4 the connector panel was brought inside of the main enclosure which will reduce the chances of moisture entering at the connectors which could result in corrosion. The sensor cables enter the enclosure via a brushed entry system which although reduces the enclosure's ability to prevent water from powerful jets it will still prevent large volumes of dust entering. To prevent any moisture ingress through drips from above a rubber seal with a flap which extends over the cable entrance was fitted to the enclosure.

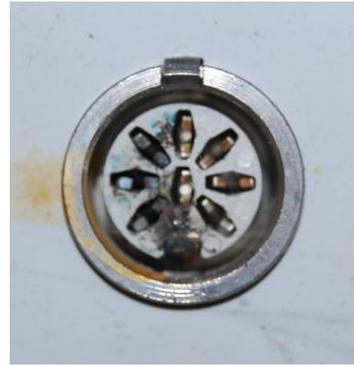
It was also noted that on the junction box for the weather instruments one of the connectors had signs of sparking. There are several explanations as to why this may have happened. One explanation and the most likely is that a build-up due to corrosion caused a short circuit between the terminals resulting in over-currents. Another explanation may be that (prior to any corrosion) moisture had seeped in, possibly due to rainfall, and this caused short circuiting between the terminals.

Figure 2: Connector sparking

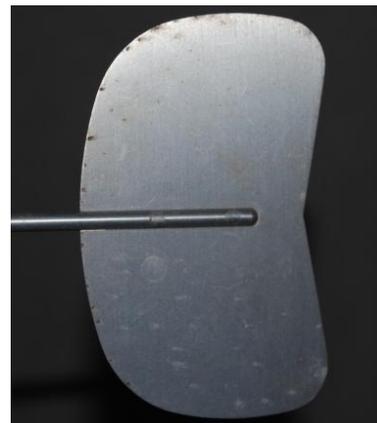
An observation made when removing the weather instruments from the met mast bracket was that the mast had been struck by lightning. A lightning rod that had been welded to the met mast was no longer present and there was evidence of hot sparks from markings on the fin of the wind vane. It is believed that the extreme currents and heat caused by the lightning strike had caused the weld to fail and thus allow the lightning rod to break off.

Figure 3: Wind vane following suspected lightning strike

As discussed in the previous section the lightning rod that was attached to the met mast was knocked off by a lightning strike. It was decided that for the new system it would be better not to have a lightning rod at all on the met mast. The reason for this was that unless the rod was fully capable of absorbing the full lightning strike and diverting the extreme current into the wind turbine's lightning system, it would do more harm than good by attracting a lightning strike. Since there was already a lightning rod on the wind turbine's own existing met mast, which sits higher than the new met mast, it would be better to allow it to absorb the lightning strike and direct the over-currents down the wind turbine's lightning protection system. Another precaution taken with regards to lightning strikes is that every part of the CMS equipment is well grounded so that any over-currents that they are exposed to can find an easy path to ground in order to prevent any damage to crucial parts of the system.

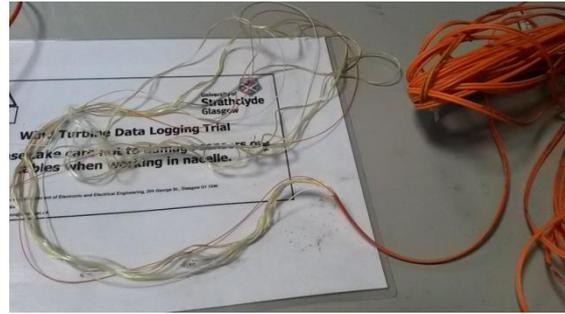
On uninstalling the system from the wind turbine it was discovered that the fibre optic cable had snapped. The way in which the cable was frayed suggests that the cable had snapped after coming under excessive strain as opposed to general wear and tear. It was therefore obvious that this break of the fibre optic cable had resulted in the loss of communications between the enclosure in the nacelle and the enclosure at the base of the tower. This was in fact the second fibre optic cable that had broken this way. It is believed that the reason for this breakage was due to a lack of slack in the cable. The fibre optic cable ran down the tower alongside the four power cables which are separated by a circular spacer. This spacer allows the cables to twist at the same time as the turbine yaws and prevents them from coming under excessive strain through twisting.

Figure 4: Frayed fibre optic cable

Fibre optic cable by its nature does not have a lot of flex in it and therefore when subjected to excessive strain will break relatively easily. To prevent the fibre optic cable from coming under excessive strain it must be installed in a way that allows it to have enough slack in it to prevent over straining yet be secured in the right places to avoid any one part bearing the weight of the cable below it. Where possible any new fibre optic cable being installed should follow as closely as possible the path of the existing fibre optic cable which is used for the wind turbine control communications. The most likely location in the wind turbine for the fibre optic cable to come under excessive strain is at the yaw deck. It is therefore crucial within this area to leave sufficient slack to be taken up as the wind turbine yaws. A turbine will typically be able to yaw two complete rotations in either direction before it corrects itself.

As stated previously the fibre optic cable was susceptible to coming under excessive strain causing it to break and therefore prevent data from being sent to the Ethernet data storage drives. To reduce this risk the routing and fixing of the cable was revised. Break points have been added to the fibre optic cable by way of patch cables and couplers. These break points have been added at the locations most susceptible to excessive strain. If the fibre optic cable comes under excessive strain the coupler will allow the main cable and patch cable to separate and avoid a breakage. In addition to the break point a spare fibre optic cable will be installed but not connected. If the one cable is damaged then the replacement can be simply connected in, again reducing data loss.

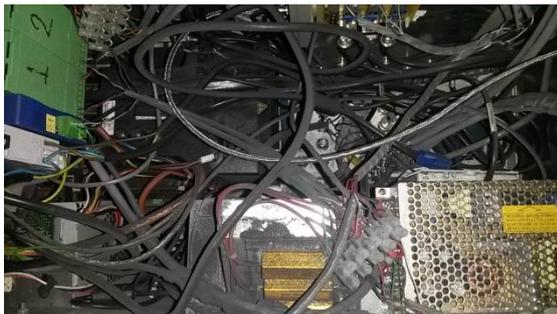
After confirming that the tower base cabinet was functioning as normal attention was moved onto the nacelle enclosure. This is the main enclosure for the CMS and houses all the crucial data acquisition hardware including a PC. On removing the enclosure cover it was found that there was a large volume of thick black dust covering everything.

Figure 1: Large volume of dust inside enclosure

By locating the UPS in a separate enclosure, the main CMS enclosure has no requirement for cooling which reduces the risk of excess dust being drawn in by fans. Mounting the UPS in a separate enclosure means that the main CMS enclosure can be smaller, lighter and have reduced electrical noise. Having an additional enclosure for the UPS means that it can also be used for the networking equipment. The enclosure now housing the UPS is mounted in an IP rated enclosure

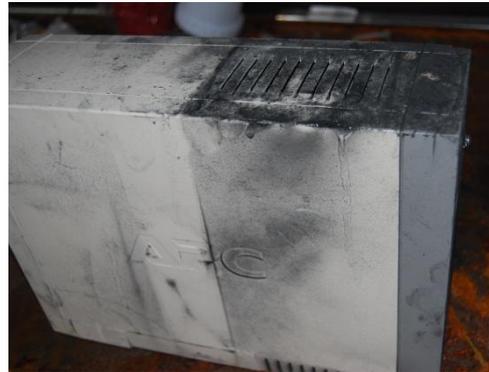
It was found that the UPS would not power on, either when supplied with external power or from a replacement battery. The UPS supplies the power to all components of the CMS within the nacelle, and therefore with it not switching on, nothing else could receive power. This behaviour suggests a serious fault with the UPS.

When the CMS was designed and built a fan was fitted on top of the UPS air inlet in an attempt to increase the circulation of cool air and prevent the UPS from overheating. However it became apparent from the level of dust within the UPS that the fan had in fact caused more harm than good by drawing dust inside of it. Part of the reason for drawing in so much dust was due to the absence of the correct fan filter which would have prevented such a level of dust passing through. However given the excessive volume of dust, even with a filter in place, airflow would soon have been

restricted as the dust saturated the filter. It is therefore believed that the dust drawn inside the UPS by the fan caused the fan to overheat, resulting in its failure.

Figure 2: Failed UPS due to excessive dust

which has fans built into it with appropriate filters to reduce the level of dust that could enter and risk over-heating. Each of the systems are also fitted with dehumidifiers to reduce moisture levels inside of them.

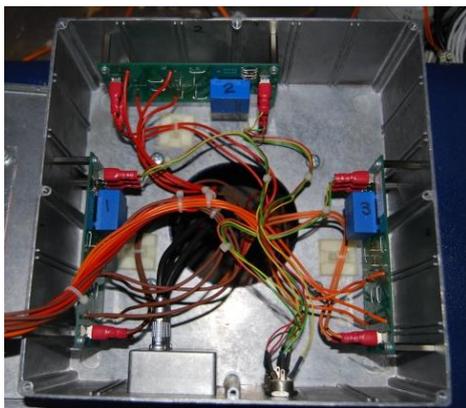
Another notable observation was the difference between enclosures that were IP rated compared to those that were not. The enclosures that had an IP rating of 56 which prevents dust and splashing liquid, had no dust inside them at all (Figure 3) compared to those that had no IP rating (Figure 1). The reason that there were enclosures with no IP rating is because they were purpose built in-house.

Figure 3: IP56 rated enclosure
