**Title:** “Arc Mapping research”

**Authors:** Nicholas Carey PhD and Niamh Nic Daeid PhD

## **Abstract**

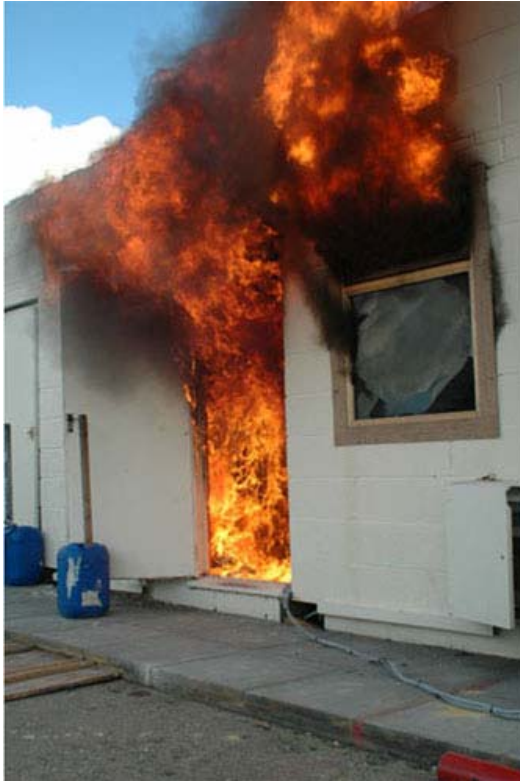
Figure 1 – a view of an experiment fire during flashover conditions.

A literature review indicated that prior to this research the reliability of arc mapping had not been established with a series of full-scale experimental fires where different compartment scenarios were repeated. Forty two fully furnished compartments (including 3 blind tests) were wired with four separate electrical circuits. This led to the generation of 141 exhibits/artefacts of electrical arcing damage to copper conductors.

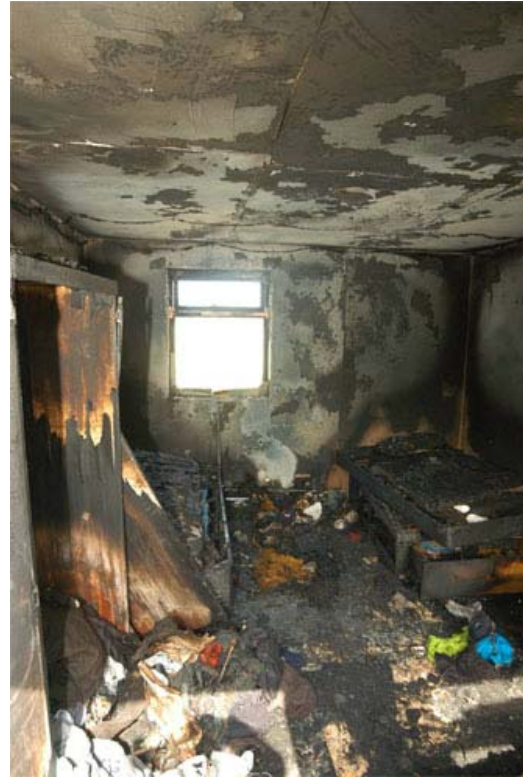
Figure 2 - a post-fire scene prior to exhibit recovery.

A careful and methodical examination of the conductors will often identify arcing damage where the fire first attacked the wiring insulation. Disposable gloves over hands are normally what are required to feel the beads, notches, welded points etc. that suggests evidence of an arcing event. Care needs to be taken not to misidentify other conductor damage in the form of alloying (eutectic melting), thermal damage, or mechanical damage that may appear to be electrical arcing damage [11, 18]. Churchward's [19] description of the conductor examination is a detailed and accurate explanation of the care that is needed to achieve this type of electrical examination at a fire scene.

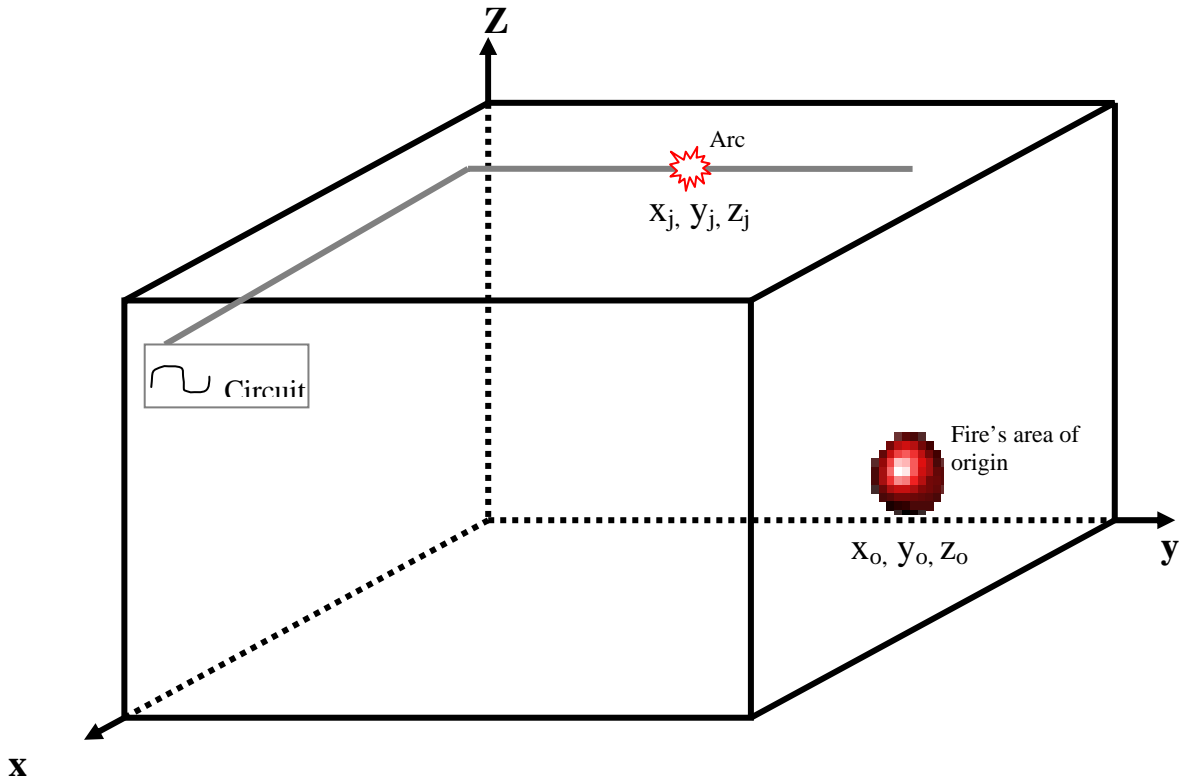
Figure 3 – Three-dimensional diagram showing the relationship between the fire’s area of origin and the arcing damage on one circuit.

One of the major issues of the research was the mathematical evaluation of the three-dimensional data collected during the full-scale experimental fires. A mathematical method was used to establish the relationship between the fire's area of origin and the arcing damage locations for the experimental fires [20].  $x$ ,  $y$  and  $z$  co-ordinates were used to describe the fire's area of origin and the arcing damage for each separate electrical circuit in the compartment. Figure 3 details the  $x,y,z$  co-ordinates for one circuit within a compartment/room. Figure 4 details a cross-sectional view of a compartment, the fire's area of origin, the actual arcing location and the minimum distance between the circuit and the fire's area of origin.  $R_{oj}$  is the distance between the fire's area of origin and the arcing damage on a circuit in the experimental fires and  $R_{min}$  is the minimum distance between the fire's area of origin location and the circuit that sustained the arc fault.

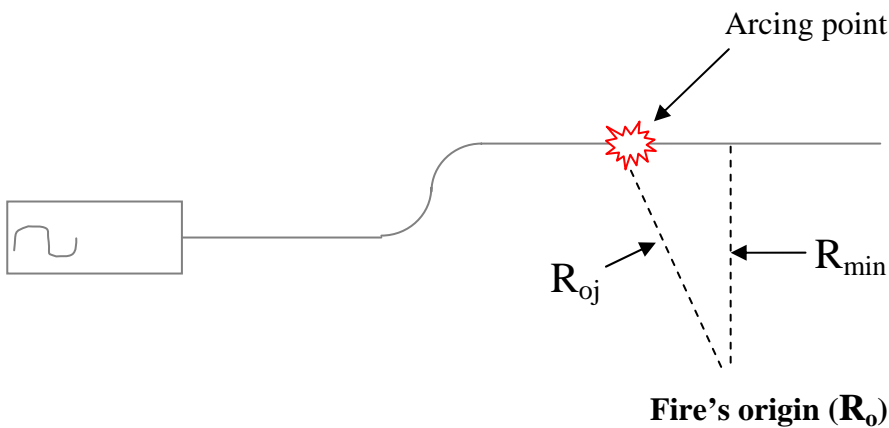
Figure 4 – A cross sectional view showing the two different distances from the fire’s area of origin to the circuit’s arcing point and the minimum possible distance.

The data for  $R_{oj}$  and  $R_{min}$  with each circuit and experiment was inputted into an Excel spreadsheet using the  $x$ ,  $y$ ,  $z$  coordinates for all locations of the area of origin for each of the experimental fires,

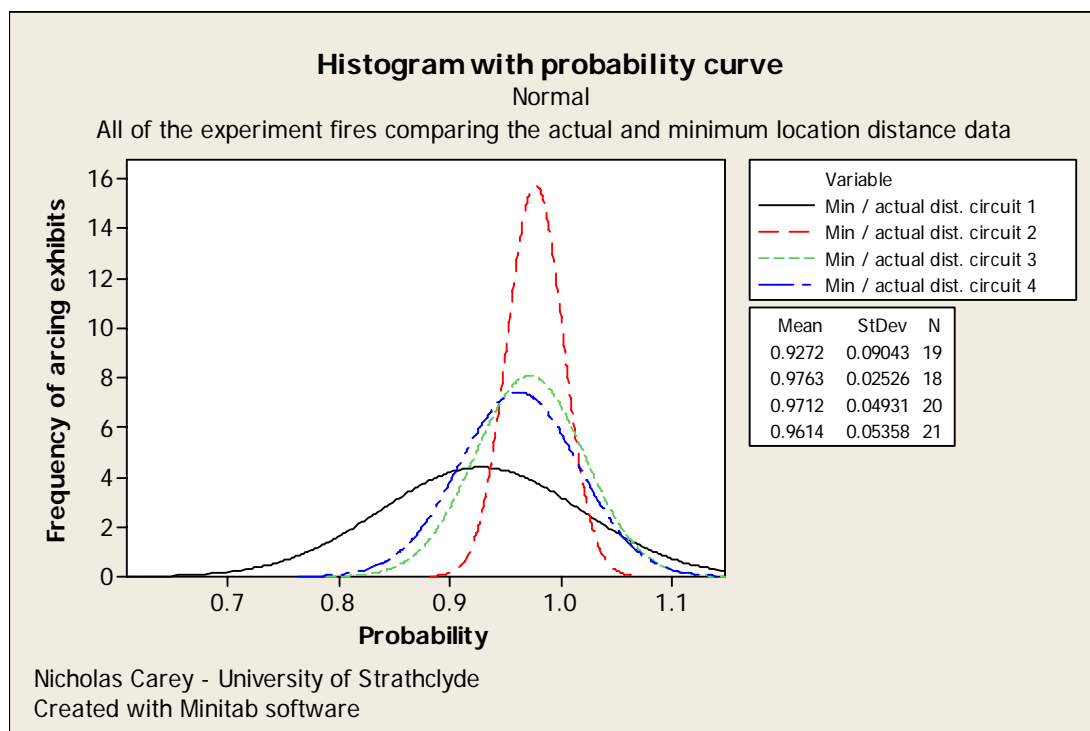
Figure 5 – Histogram detailing the probability of the arcing damage compared to the closest point on a circuit.

The spreadsheet data was imported and analysed with the statistical software package MiniTab version 15 (Minitab Inc. State College, PA. USA) and the results are detailed in figure5. This software package was able to display all four separate circuit results on to one histogram chart.

Statistical analysis suggests that the majority of the arcing events occurred on the electrical circuits within a short distance or adjacent to the closest possible points on the circuit to the fire's area of origin. The majority of the probability results were in the 0.85 to 1.0 range (at a 95% confidence level). This suggests that there is a high probability (85% or higher at the confidence level tested) that the arc occurred within a close proximity to the fires area of origin.

A reduced probability for circuit 1 was observed for almost all of the experiments. The location of the cable for circuit 1 (the power ring circuit) was consistent throughout all of the experimental fires. The cable was located at the junction of the top of the walls and the ceiling. The fire dynamics appear to have slightly delayed the exposure of the PVC insulation to the heat flux in the fire's early development resulting in arcing damage occurring further away from the area of origin in some cases and resulting in a greater spread of results.
