Designing for Reliability in Wind Turbine Condition Monitoring Systems

2.0 Vestas V47 Condition Monitoring System

3.0 New and Improved CMS for a Vestas V42 Wind Turbine

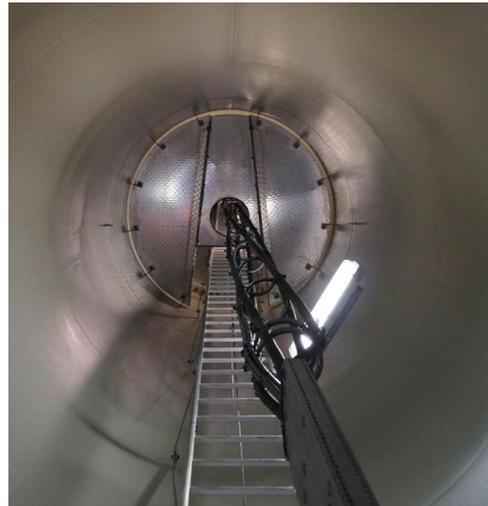
Figure 5: Wind turbine tower with power cables in centre

Fibre optic cable by its nature does not have a lot of flex in it and therefore when subjected to excessive strain will break relatively easily. To prevent the fibre optic cable from coming under excessive strain it must be installed in a way that allows it to have enough slack in it to prevent over straining yet be secured in the right places to avoid any one part bearing the weight of the cable below it. Where possible any new fibre optic cable being installed should follow as closely as possible the path of the existing fibre optic cable which is used for the wind turbine control communications. The most likely location in the wind turbine for the fibre optic cable to come under excessive strain is at the yaw deck. It is therefore crucial within this area to leave sufficient slack to be taken up as the wind turbine yaws. A turbine will typically be able to yaw two complete rotations in either direction before it corrects itself.

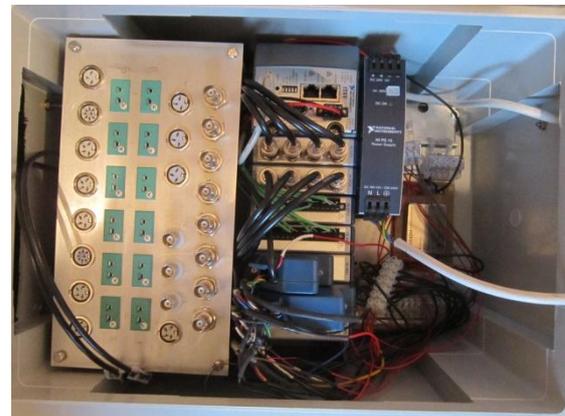
Figure 4: New CMS enclosure

The use of a cRIO also allowed the main CMS enclosure to be significantly smaller in size. Figure 4 shows the new CMS enclosure. The cRIO can be seen located in the centre of the enclosure with its power supply sitting to its immediate right. The 24Vdc power supply for the cRIO is also used to supply power to all of the sensors. A DC-DC converter seen on the right-hand side of the enclosure is used to convert the 24Vdc in to ± 12 Vdc and 5Vdc required for different sensors.

As can be seen from Figure 4 the connector panel was brought inside of the main enclosure which will reduce the chances of moisture entering at the connectors which could result in corrosion. The sensor cables enter the enclosure via a brushed entry system which although reduces the enclosure's ability to prevent water from powerful jets it will still prevent large volumes of dust entering. To prevent any moisture ingress through drips from above a rubber seal with a flap which extends over the cable entrance was fitted to the enclosure.

In Figure 4 the connector panel can be seen on the left hand side of the main CMS enclosure. On the previous system the connector panel was mounted on the outside of the enclosure. This however meant that the sensor connectors were susceptible to being knocked off or damaged whilst maintenance work was being carried out in the nacelle. For this reason it was decided that it would increase system robustness to have the connector panel inside the enclosure. The sensor connectors enter the enclosure via a brushed opening which allows the connectors to pass through but reduces the exposed area in which dust may enter.
