GT2012-69065

DEVELOPMENT OF A ROBUST STRUCTURAL HEALTH MONITORING SYSTEM FOR WIND TURBINE FOUNDATIONS

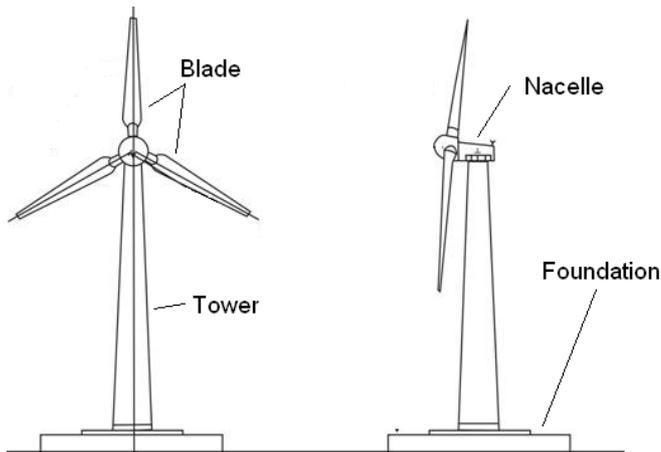
Figure 1 shows a usual arrangement of an onshore wind turbine, with blades, tower and gravity concrete foundation. Main types of foundation-tower interface used for large onshore turbines are the 'embedded can' and the 'bolted'.

Figure 1: MAIN STRUCTURAL COMPONENTS OF A TURBINE

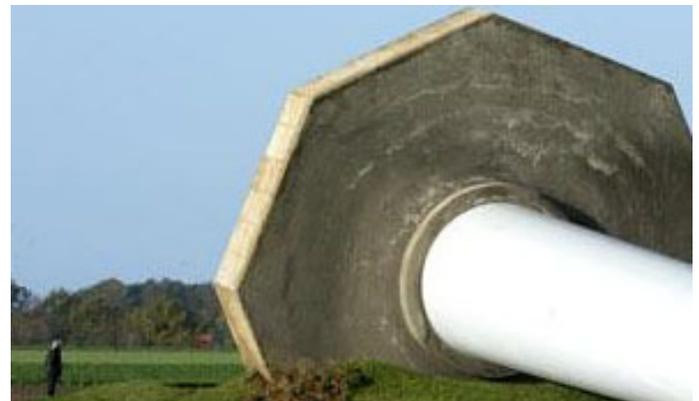
Long-term cyclic loading causes the foundation-soil interface to degrade resulting in a reduced rotational stiffness which in return decreases the bearing capacity of the soil. In this case, gravity foundations exhibit large differential movement and can tilt under a high lateral wind load as witnessed by the catastrophic failure of a wind turbine concrete foundation during a heavy storm in Goldenstedt, Northwestern Germany in 2002 where it appears the eccentric load severely damaged the soil subgrade causing the turbine to overturn (see Figure 2).

Figure 2: GOLDENSTEDT WIND TURBINE COLLAPSE

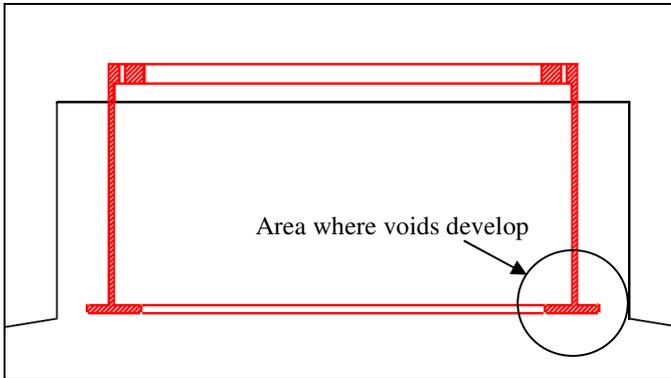
Figure 3 shows the area where voids can develop in a concrete foundation for embedded can type connections when the turbine is subjected to eccentric and cyclic loading. Water ingress through the damaged concrete-web interface coupled with the movement of the tower can interface acts to exacerbate the level of movement through erosion. The presence of voids around the embedded can allows the whole tower to move significantly in the vertical direction as well as to a smaller extent in the horizontal direction. There has been no published work relating to this type of displacement but movements in the

range of 5mm were noted during a site visit with reports of movement up to 20mm on other turbines at the same site.

Figure 3: FAILURE MODES (EMBEDDED CAN)

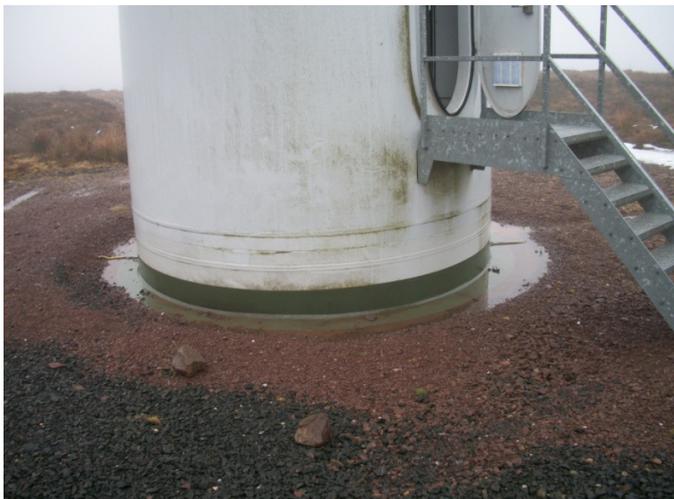
A novel sensing solution is proposed to monitor the state of large scale multi-MW wind turbine foundations. The system has been designed for ‘embedded can’ style foundations. The only data currently gathered on the tower movement is based upon accelerometer readings from the nacelle. This data does not give specific details on the foundation. It is unknown how widespread the problems are due a lack of published data relating to wind turbine foundations. As existing embedded can foundations will be in operation for the next 20 – 25 years a suitable monitoring system is desirable. The machines involved in the study were Vestas V80 2.0MW [9] turbines constructed in the last 10 years. During a site visit eight different turbines were inspected. The turbines showed varying degrees of movement. A further turbine was inspected which had undergone remedial work. Figure 4 displays the general layout of a turbine on site.

Figure 4: EMBEDDED CAN, TOWER AND FOUNDATION

The top section of the foundation is completely buried under back fill. The embedded can sits around 30mm above the top of the pedestal and is joined internally to the lower tower section. Due to this construction technique, any movement of the can results in an equivalent movement of the tower and nacelle structure above.

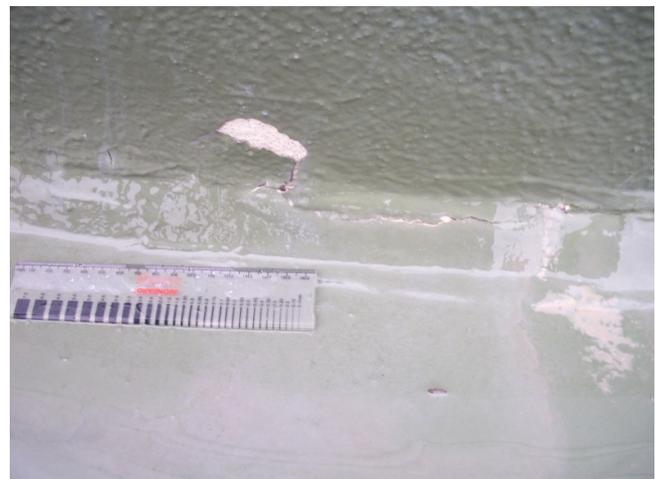
1. Small movements of the tower are possible due to the low level of friction between the painted can and the concrete. As the tower moves during operation the green plasticized waterproof membrane eventually cracks. Cracking occurs principally around the area between the pedestal and the penetrating steel can. This is shown in Figure 6.

Figure 6: WATERPROOF MEMBRANE CRACKING

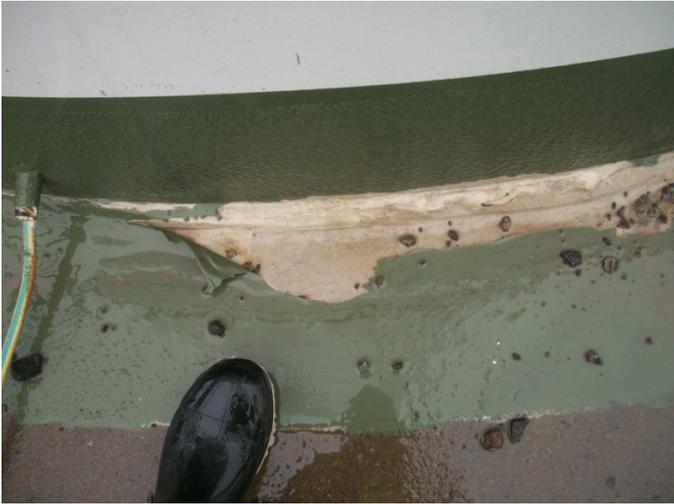
There was no evidence that cracking was only occurring in a uniform manner. Some turbines had only small single cracks whereas others have cracks extending to around 2m around the circumference of the foundation/tower connection. This is illustrated in Figure 7.

Figure 7: WATERPROOFING DETERIORATION

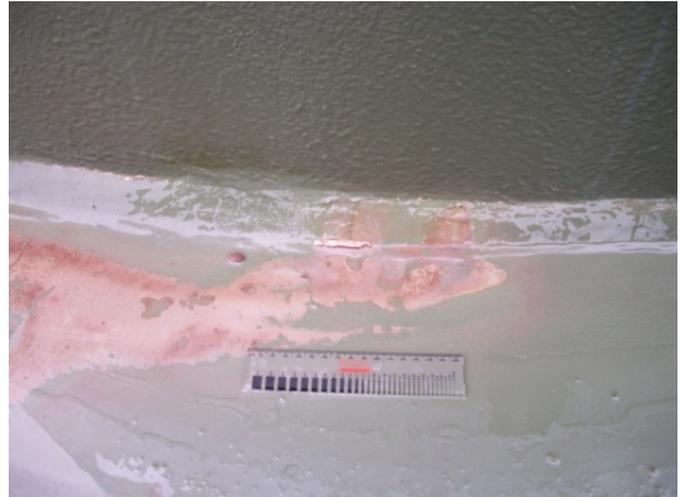
4. Evidence of internal foundation erosion is visible at the surface in the form of cementitious deposits being pumped through the cracks at the top of the foundation pedestal (Figure 8). Larger particles that become dislodged such as aggregate are broken up inside the foundation.

Figure 8: CEMENTITIOUS DEPOSITS EMERGING FROM BASE

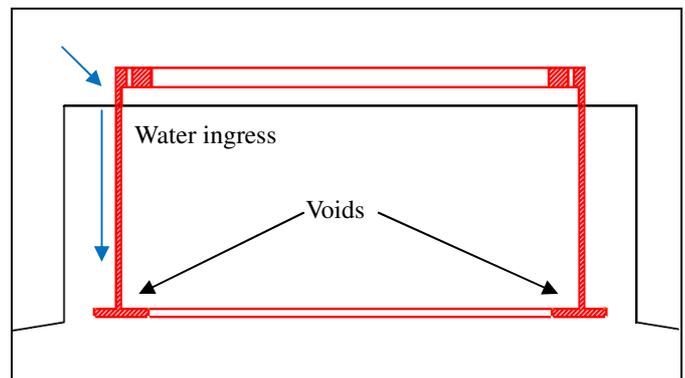
5. Voids are created where material is eroded. The presence of voids has been confirmed through the use of remote cameras inserted into the foundation through small boreholes. Video evidence, on this specific foundation, shows the steel can moving in the vertical direction and water being transported around it. Figure 9 illustrates the ingress and location of voids.

Figure 9: FAILURE MECHANISMS

6. As the depth and width of the void increases the steel can is able to move more in the vertical direction as well as to a smaller extent in the horizontal direction. Erosion is possible both beneath and on the upper side of the flanges.

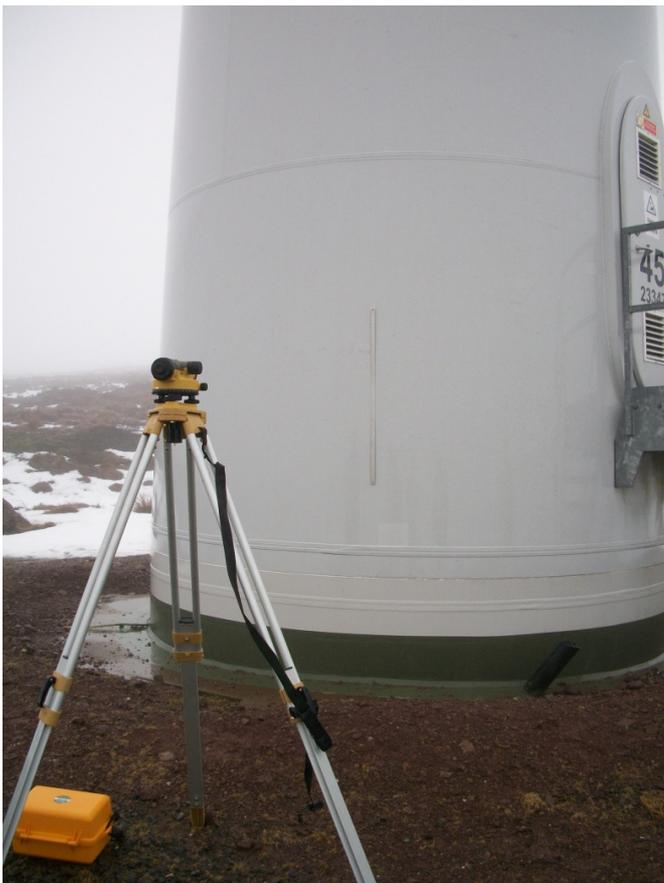
Current monitoring for the wind turbines in the study involves a technician visiting each turbine on a regular basis to record visible movement. Inspections are increased when there is a significant change in the magnitude of vertical movement. This method of inspection is time consuming and costly as well as being unavailable for extended periods during winter conditions. The typical measurement approach is illustrated in Figure 10 and incorporates a sight and rule which is magnetically attached to the turbine tower. The technician on site calls for the operating station to request the turbine to be temporarily paused. The greatest movement could be seen during shutdown when it is operating at or above its rated wind speed.

Figure 10: MEASURING DISPLACEMENT MANUALLY

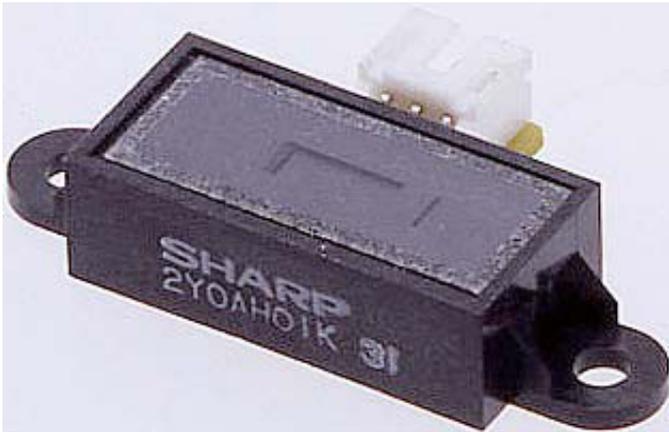
Off-the-shelf infrared sensor have an integrated position sensitive detector (PSD) and infrared emitting diode (IRED) [10]. A typical view of the sensor is illustrated in Figure 11.

Figure 11: PSD/IRED DISPLACEMENT SENSOR

The sensor functions by sending an infrared signal towards a reflective surface. The signal is then reflected back to the sensor where it is picked up by the receiver. As the displacement between the sensor and the target reflector increases the voltage output of the device reduces.

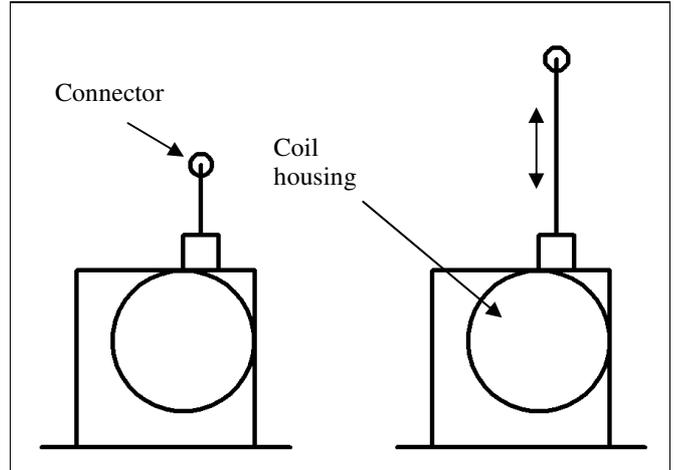
Draw wire sensors (or string potentiometer) could also be used for the SHM application in a wind turbine foundation. Unlike the IRED sensor the draw wire sensor is always connected to both the foundation and the can/tower. As the can displaces the draw wire uncoils as is shown in Figure 12. The electrical output of the device changes with displacement. Draw wire sensors have been used in SHM application successfully including bridge monitoring in China [11] and landslide monitoring in the USA. This type of sensor is one of the most robust due to the lack of any optics which need extra protection in the foundation to prevent them being splashed by residues falling from the nacelle above.

Figure 12: DRAW WIRE SENSOR

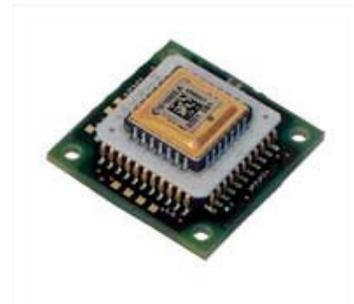
Displacement of the turbine can be measured with low-cost, high-rate wireless 3D micro-electro-mechanical systems (MEMS) accelerometers. The MEMS contain microscopic plates that get stressed by dynamic forces causing a change in the voltage response. They usually use the piezoelectric or capacitive effect to measure acceleration. A typical 3D MEMS sensor is illustrated in Figure 14. Each sensor is capable of measuring the dynamic response of the tower base in three directions. Signal processing techniques are used to convert the accelerations into displacements.

Figure 14: WIRELESS MEMS DISPLACEMENT SENSOR

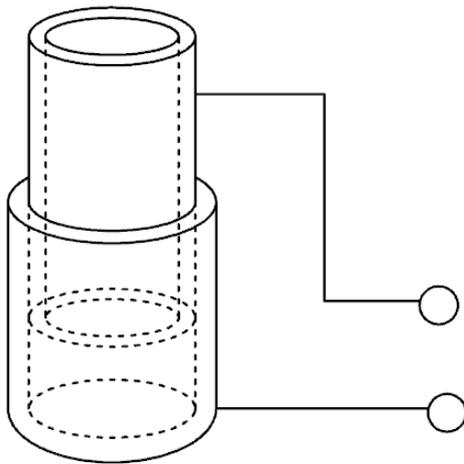
The sensor which has been selected for the foundation is a capacitive displacement sensor. The approach has been demonstrated previously in another SHM application on a road bridge in the form of a wirelessly powered peak displacement sensor [12]. The main difference is the sensor will be used for real time sensing capability rather than only peak displacements. This allows trending functionality with wind speeds which can assist in gaining a greater understanding of the failure factors. The sensor consists of two aluminium tubes which act as capacitor plates. As the steel can moves relative to

the static foundation the capacitance of the device changes as the area of overlapping contact area decreases. The sensor is connected to a voltage source and capacitance. As the displacement varies the overlapping area of the capacitance plates changes in a proportional manner. The varying capacitance results to voltages changes which can be digitally captured and processed. The basic layout of the two capacitor tubes is displayed in Figure 13.

Figure 13: CAPACITOR LAYOUT

The capacitance (C) varies proportionally to the overlap height of the two cylinders (h) as shown in Eqn. (1). It is also proportional to the dielectric constant (K), the air permittivity (ϵ_0) is the permittivity and inversely proportional to the distance between cylinders (d).

$$C = 2\pi K\epsilon_0 \frac{rh}{d} \quad (1)$$

$$\frac{dC}{dh} = 2\pi K\epsilon_0 \frac{r}{d} \quad (2)$$

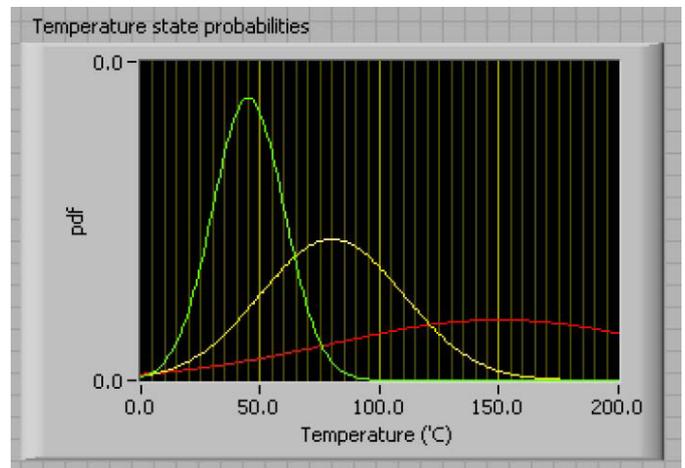
To analyse data from each sensor a Bayesian inference program will be used. Initially, probability density functions (pdf) are created for each foundation condition (Green, Amber and Red). An example is shown in Figure 14 where three pdfs for three component temperature conditions are displayed. For the foundation monitoring system temperature will be replaced with displacement.

Figure 14: PROBABILITY OF A TEMPERATURE GIVEN COMPONENT CONDITION IS: GOOD, ABNORMAL OR CRITICAL

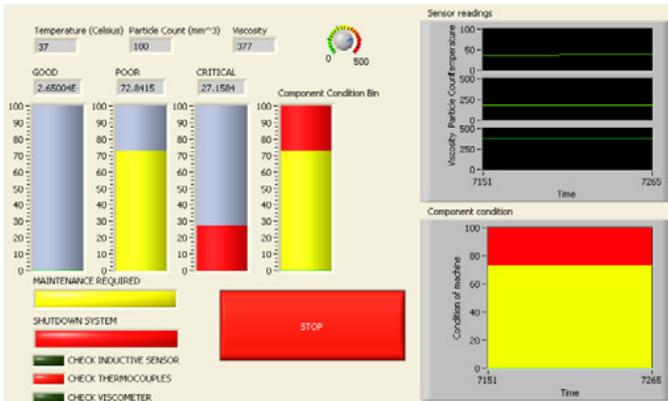
Once the sensor is active, data is fed into the Bayesian inference program (BIP) where it determines the state condition of the foundation. The output is a simple traffic light system which is easy and quick to interpret by the technician staff monitoring the foundations. Three typical operating modes are displayed in Figure 15 for a wind turbine monitoring. The wind turbine foundation monitoring solution will be simpler as it will only track a single input value. It is envisaged that additional inputs, such as wind speed will be added. It is also quick and easy to change the levels of each of the three conditions, for example to change the critical limit from 5mm displacement to 6mm.

Figure 15: CRITICAL CONDITION

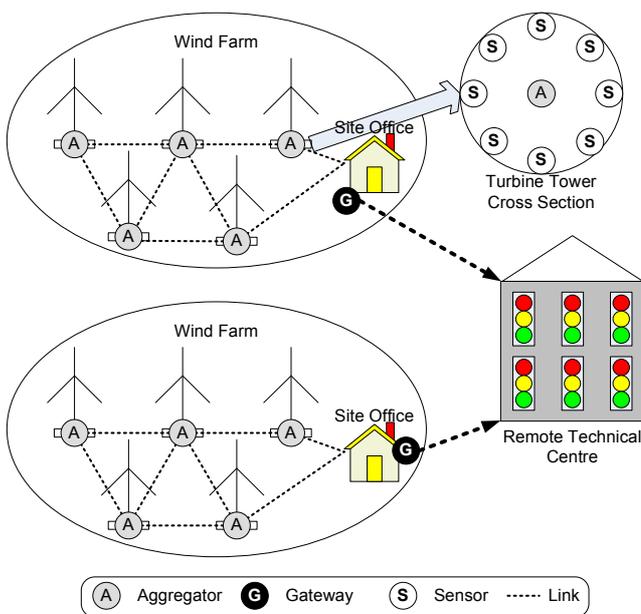
A proposed communications system architecture is shown in Figure 16. Multiple sensors (S) will be deployed on the turbine foundation sampling continuously for displacement and report the measurements to a data aggregator device (A) located in the turbine. The communications between the sensors and the data aggregation device could be either wired or wireless. In order to reduce the installation cost and ease deployment a wireless solution based on the widely used and mature communications standard IEEE 802.15.4 [13] will be adopted. Using this technology devices can operate for more than 3 years with two AAA batteries reporting every 10 seconds [14] making it ideal for SHM applications.

Figure 16: COMMUNICATION SYSTEM ARCHITECTURE

Aggregator devices are used to combine measurements from the displacement sensors in order to create a displacement profile of the tower as a whole. Also correlation of displacement readings and measurement verification can be achieved at this level (for example elimination of ambiguous readings from sensors placed on the same proximity).

After initial processing, the aggregator devices transmit the combined measurements over the existing SCADA infrastructure to the Remote Technical Centre (RTC) for further processing and classification using a traffic-light system (green, amber, red). The classification and processing will be performed by Bayesian Inference Program and allow the Human Machine Interface (HMI) to display the status of each individual turbine in an easy to understand format. In this scenario the gateway devices (G) shown in Figure 16, are not necessary since communications are handled directly by the existing SCADA infrastructure. Also note that the Bayesian Inference Program will be executed in the Remote Technical Centre.

For wind farms where SCADA infrastructure is restricted or not available due to warranty issues, an autonomous communications solution will be provided. In this scenario, aggregator devices will transmit aggregate measurements to a gateway device (G) which is physically located in the Site Office. The gateway device will have two communication interfaces:

- A wireless interface to communicate with the aggregators. This interface will be based on IEEE 802.15.4 and enlist the aid of aggregators to route measurements from remote locations of the wind farm (i.e. turbines which do not have a direct link to the site office due to limited range).
- An Internet capable interface (i.e. GPRS/HSDPA, WiMAX, Ethernet, ADSL, Cable) for communications with the Remote Technical Centre.
